Finger Pier Renovations

**Stroud Pence Structural Engineers
Underwater And Topside Pier Investigation
Fort Monroe**

July 3, 2014

Subject: Underwater and Topside Pier Investigation - Fort Monroe

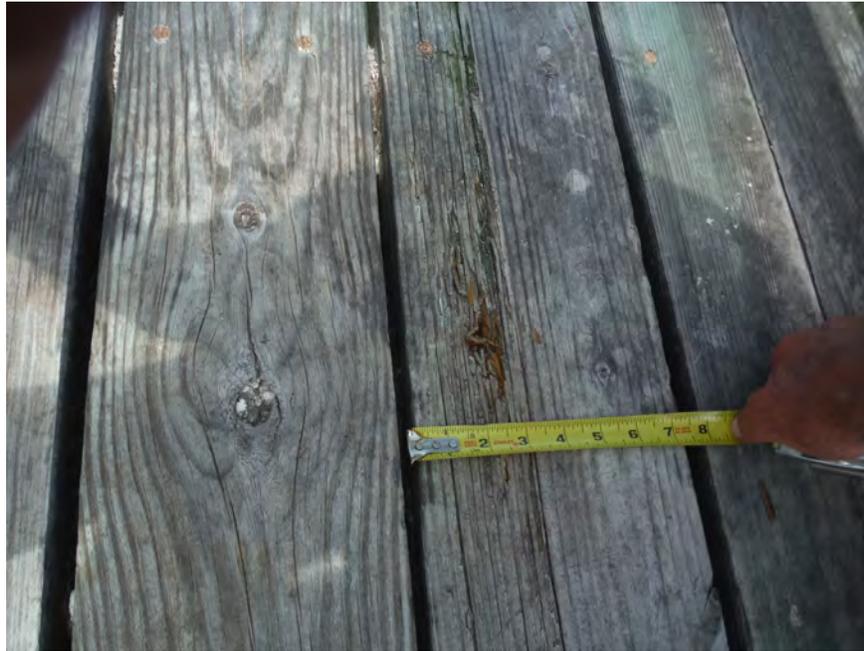
- There were (6) deck boards with soft wood which exhibited 1/2" pick penetration. Boards were easy to flex when walked on. These boards were noted to be in Poor condition. All other deck boards appeared to be in Good condition. Please see Appendix A for an approximate location of the boards that need to be replaced (Please See Photo #1, #2, and #3).

Photo 1: 2nd deck board from pier head that needs to be replaced.

- Replace the six (6) deck boards noted in the findings section and illustrated in the drawings with a new 2" X 8" pressure treated lumber with CA-C 0.06 pressure treatment concentrations.
- Replace the middle handrail board between handrail post #11 & #13 on the East side with a new 2" X 6" pressure treated board with CA-C 0.06 pressure treatment.

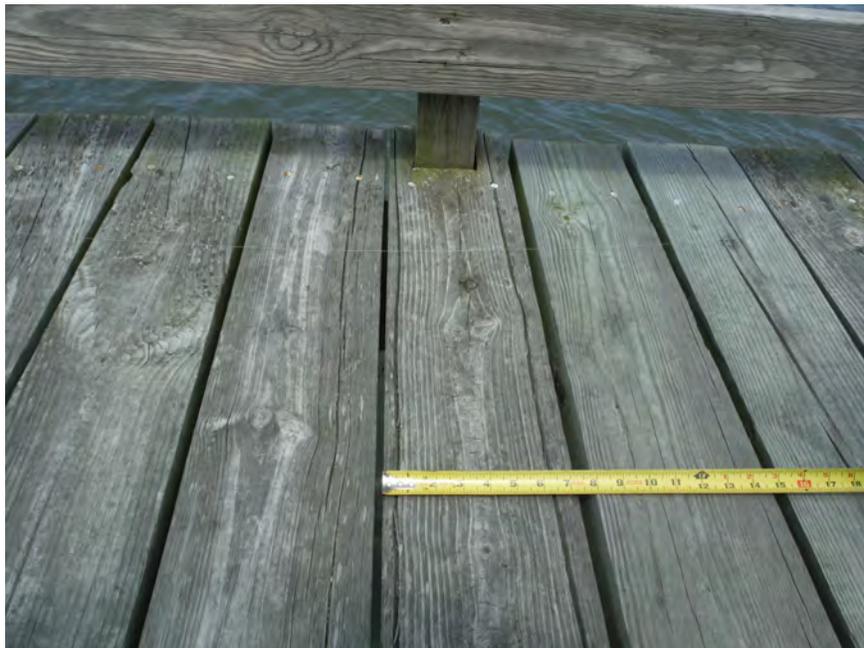
Photo 2: Deck board found at 3rd handrail post that needs to be replaced.

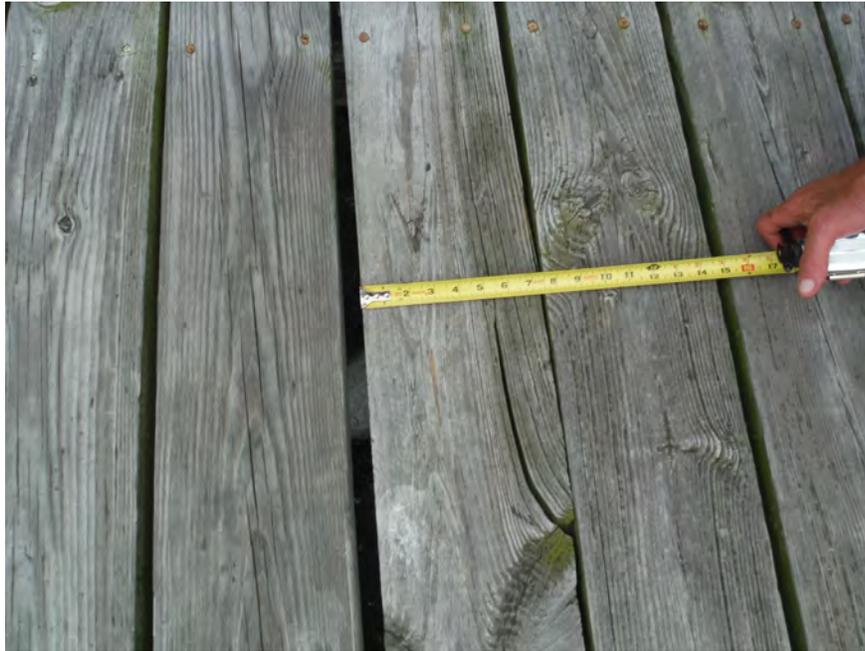
Photo 3: Deck board found at 8th handrail post that needs to be replaced.

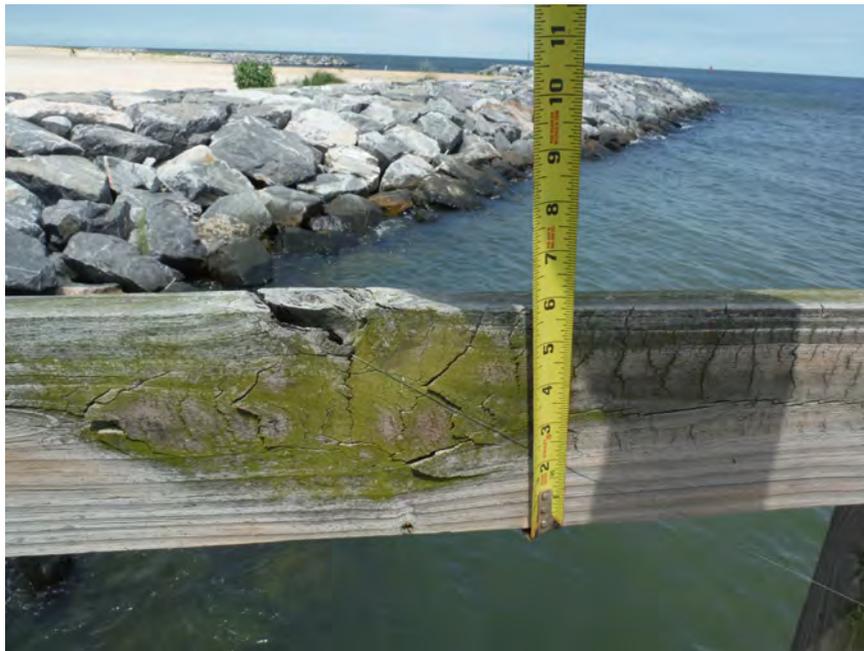
- The overall condition for the hand rail structure was noted to be in Poor condition. The majority of the hand rail and hand rail post appeared to be in Good condition, except for the middle 2" X 6" board on the East side handrail between the #11 and #13 handrail post. This board was found to be significantly splintered and in Poor condition defining the handrail structure as being rated in Poor condition (Please See Photo #4). The replacement of this board rated as poor would allow for the handrail structure to be rated in Good condition.

Photo 4: Middle guardrail board between handrail post #11 and #13 on East side of pier.

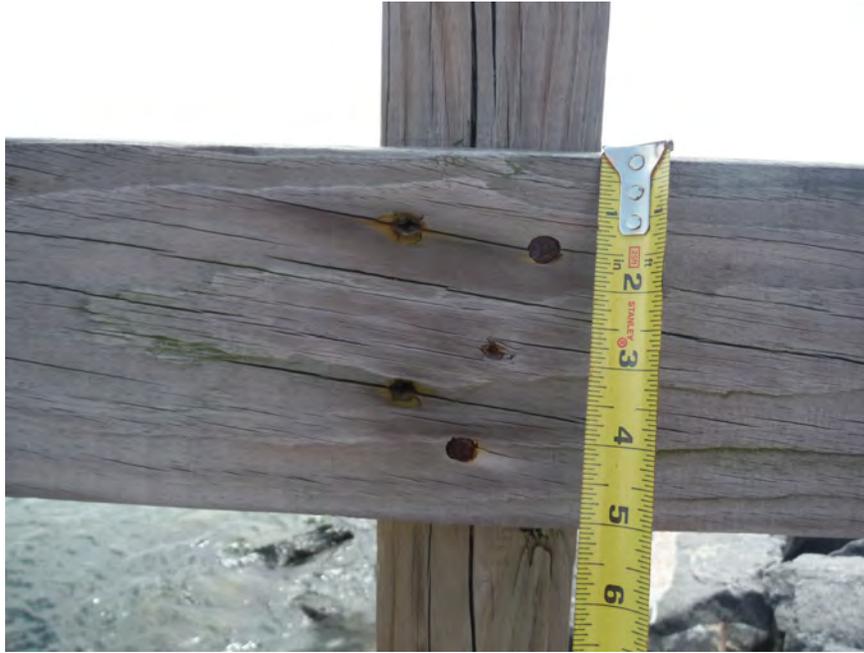
- Topside hardware appeared to be in Good condition with recently installed fastening screws (Please Photo #5).

Photo 5: Typical fasteners holding guardrail boards to handrail post.

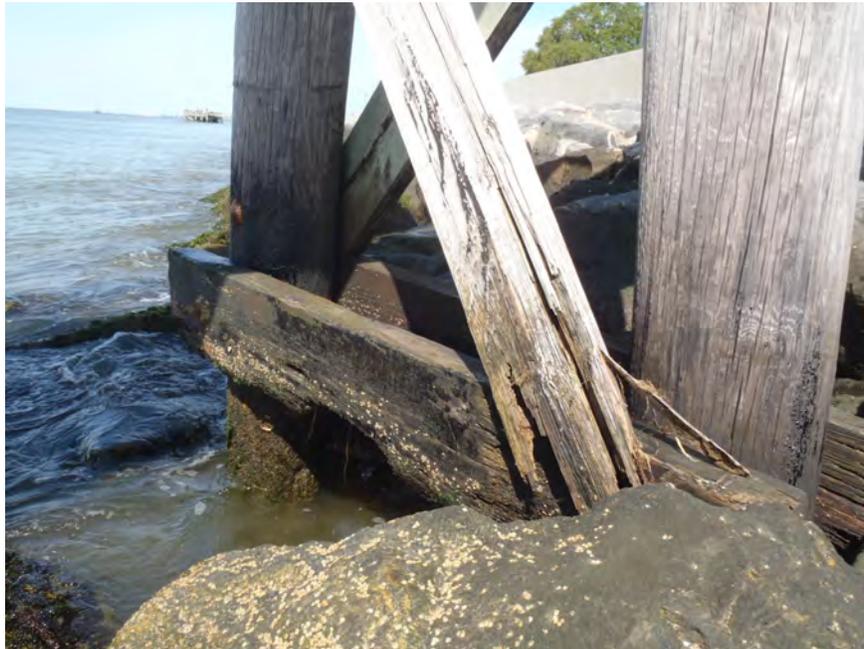
- At waterline area, all components are in Poor condition. At the waterline approximately 80% of the diagonal cross brace boards are in Failing condition with minimal structural support contributed by the lower bolting hardware (Please See Photo #6). The lower horizontal cross brace boards are in Poor condition with significant splitting and section loss. The bottom of horizontal cross brace boards were found to have an arch cut on the bottom side (Please See Photo #7). It was not determined what the purpose of this arch is for.

Photo 6: Typical deteriorated diagonal cross brace found at Bent #10

- Replace deteriorated 3" X 10" diagonal cross braces due to significant section loss and rot found at the waterline with pressure treated board with 2.5lb CCA treatment concentrations.

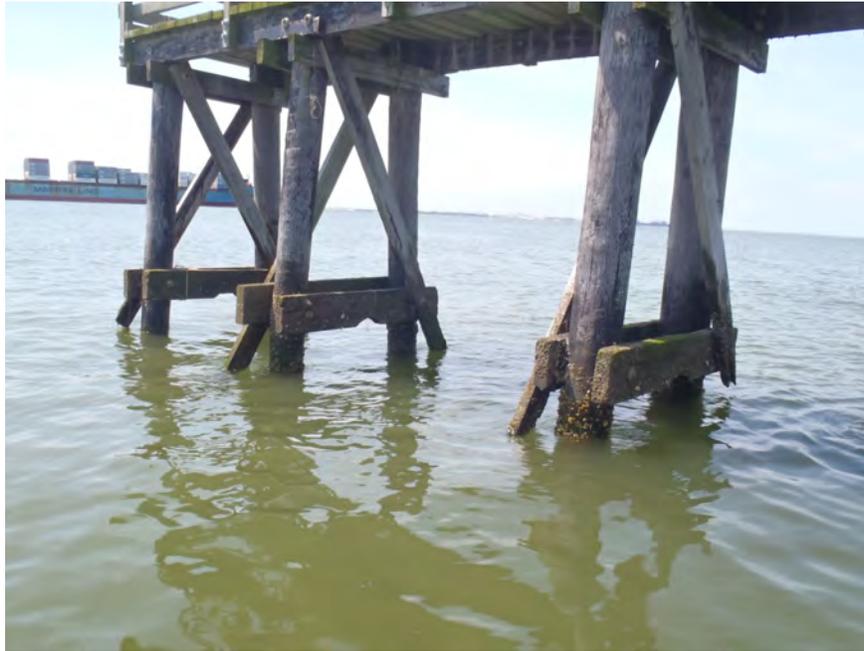
Photo 7: Typical arch cut into underside of horizontal cross brace at Bent #1 - Bent #3.

- Replace all 1" diameter hardware located at the waterline with galvanized hardware.
- Replace deteriorated horizontal 3" X 10" horizontal cross braces located at the waterline with pressure treated board with 2.5lb CCA treatment concentrations.

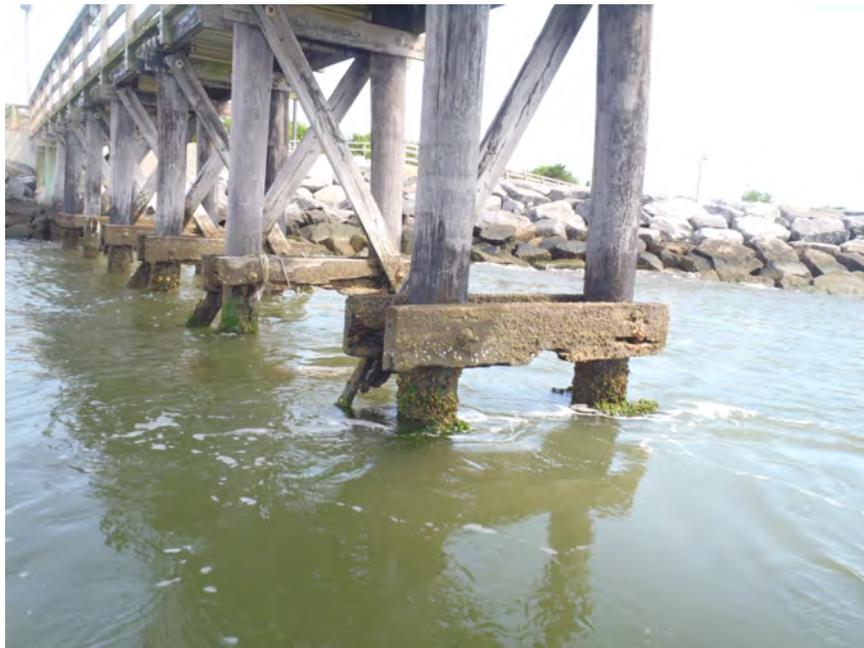
- One diagonal cross brace on the channelward side of Bent #4 was found to be missing (Please See Photo #8).
- Approximately 70% of 1" diameter fastening hardware at waterline was found to be in Poor condition.

Photo 8: Missing diagonal cross brace found at Bent #4.

- Replace the missing 3" X 10" diagonal cross brace located on the channelward side of Bent #4 with new 3" X 10" pressure treated board with 2.5lb CCA.

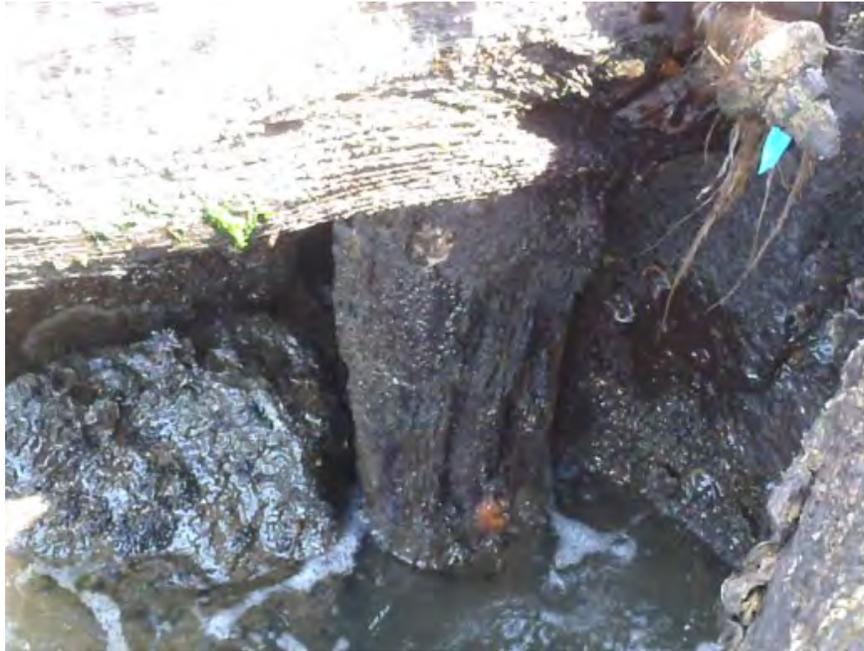
- Due to the significant section loss in Bent #10 (East and West), the piles are rated Very Poor condition. Pile Bent #10 contained the most significant deterioration with the East pile exhibiting approximately 50% deterioration and the West pile exhibiting approximately 30% deterioration at the waterline (Please See Photo #9). Piles at Bents #9 and #5 contained piles that were determined to be in poor condition with 20% deterioration at the waterline.

Photo 9: View of East pile at Bent #10 exhibiting 50% section loss to the pile at the waterline.

- Replace Bent #10 piles (East and West) with new 10" diameter Pressure treated timber piles containing 2.5lb CCA. Due to the 50% and 30% section loss in both piles of Bent #10 it is highly recommended that these piles are replaced. Section loss to this magnitude significantly decreases the structural capacity of the pile in both the axially and laterally loaded configurations.

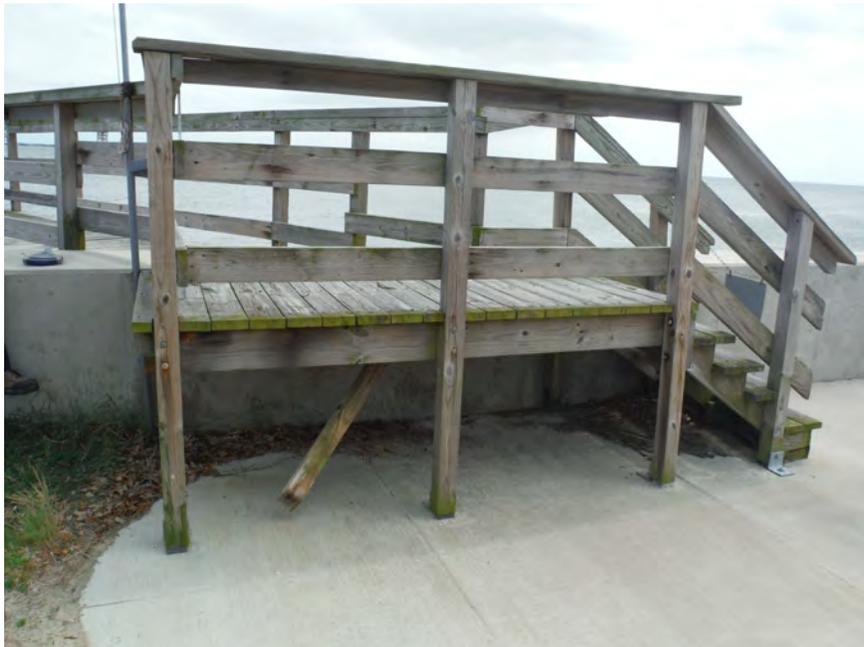
- The 2" X 4" deck joists supports on the North side of the access platform were found to be in Poor condition. The deck joists supports were found hanging from beneath the deck (Please See Photo #10).
- No other deficiencies were noted

Photo 10: Hanging deck joist stiffener found on stairway access at the North end of pier.

- Replace deficient deck joist supports with new 2" X 4" pressure treated lumber containing CA-C 0.06 pressure treatment concentration.
